**Cropwell Bishop Memorial Hall**

**Building Survey**

**A Detailed Property Inspection Report**

Inspecting Surveyor: Ian Prince, MRICS MBEng

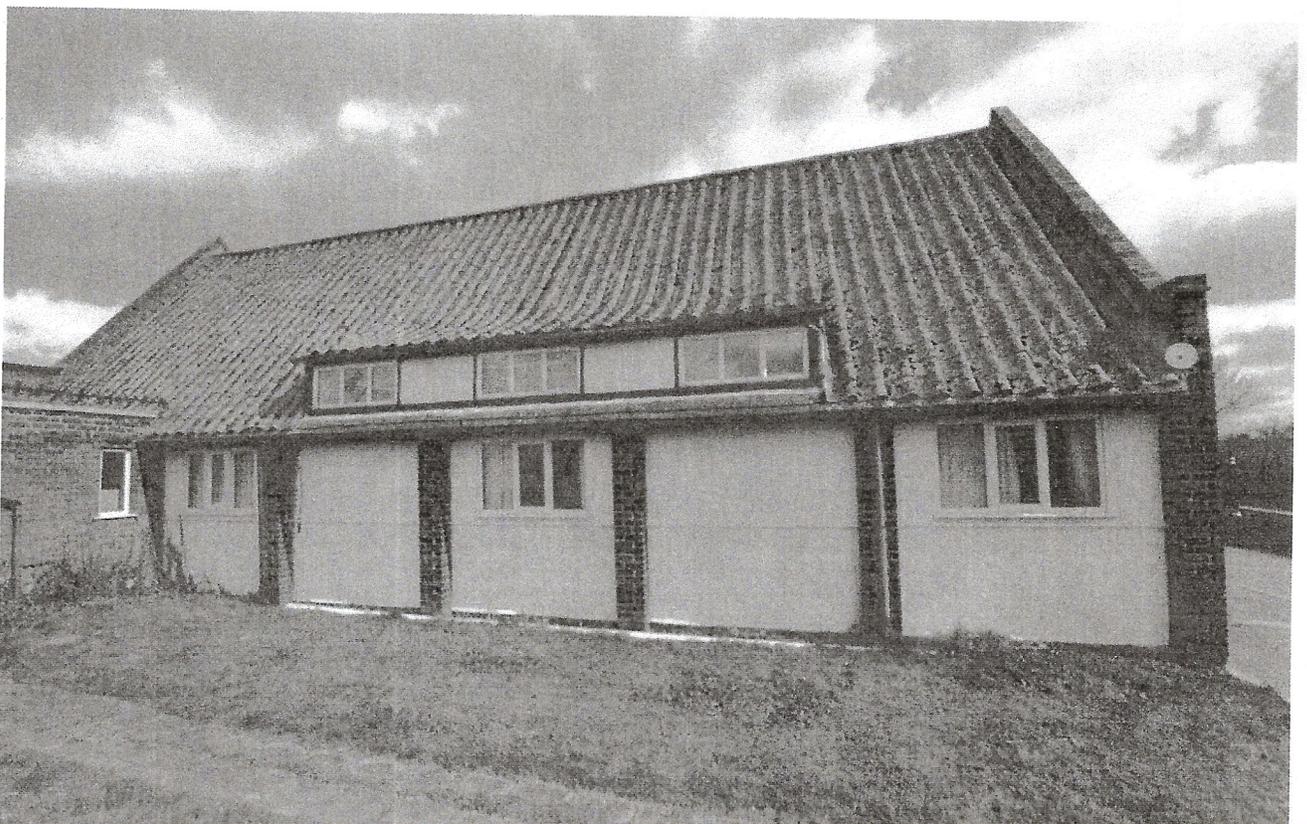
The main roof to the hall has a lightweight timber framework, visible within the roof void, supporting the main pitched roof coverings of suspected asbestos pan tiles. This covering is relatively lightweight, and whilst likely to contain asbestos fibres, which are a health risk if damaged or broken, it has probably not been replaced in the past due to the associated need to provide a more substantial supporting structure, which in turn would impact upon the walls and foundations. The roof has a secondary underlay of timber, onto which the tiles are fixed, probably utilising battens, although these could not be seen.

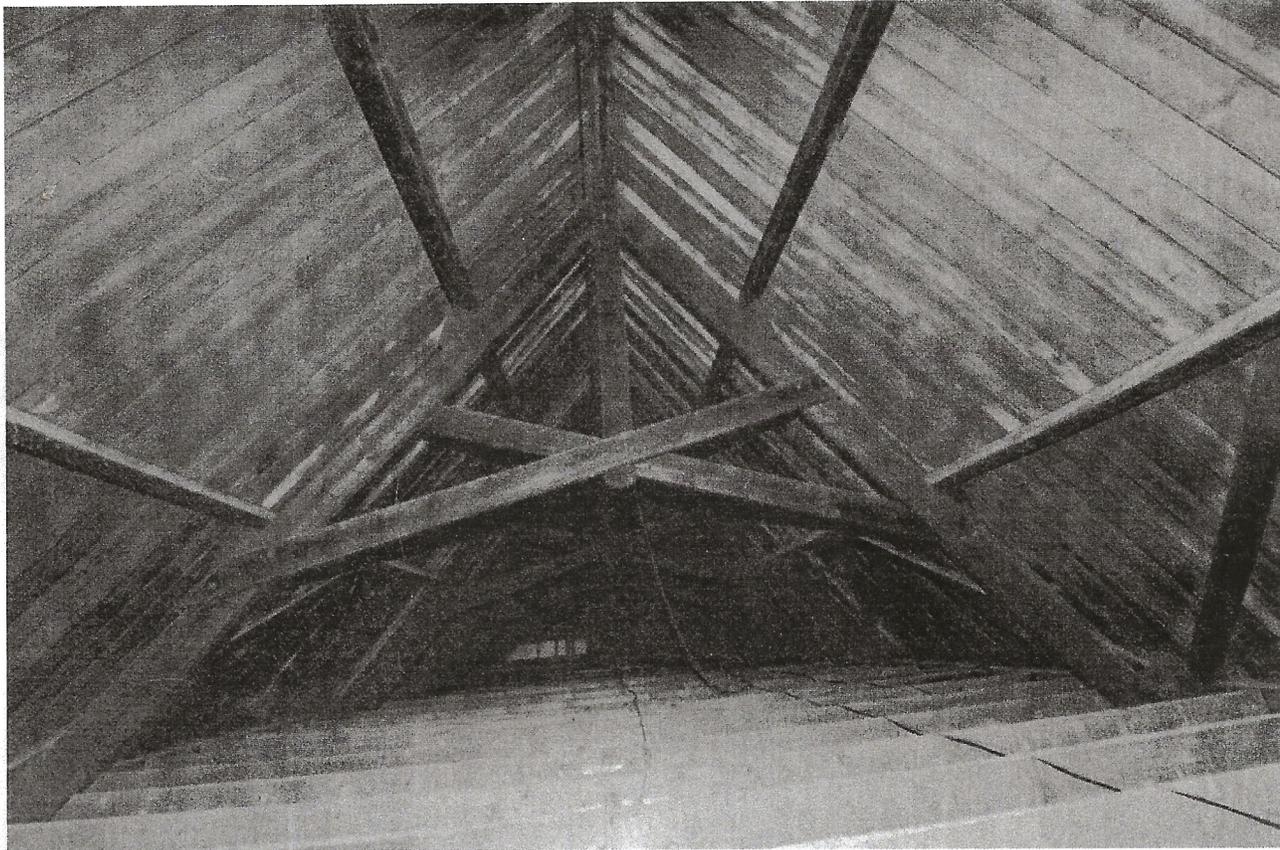
The roof therefore is considered to have a limited future life, and any significant deterioration of the roof tiles should be the trigger for the renewal of the hall as a whole. However, from what could be seen, the condition of these tiles appears as though they are likely to remain serviceable for the short to medium term. You may however find the limited number of contractors prepared to work on such a roof may make repairs more expensive.

Some staining to the inside of the main roof void suggests past leakage although this may be old. The area ideally should be checked during heavy rainfall.

Staining was also evident to the inside of the front gable wall adjacent to the purlin roof timber to the right hand side of the building. This appears to be due to leakage from the parapet or flashings above, and if this has not been previously addressed, then a competent roofing contractor should be asked to provide a quotation for renewals and repairs to ensure watertightness. Parapet walls are dealt with below but require repairs and repointing and may be the source of some of this moisture penetration.

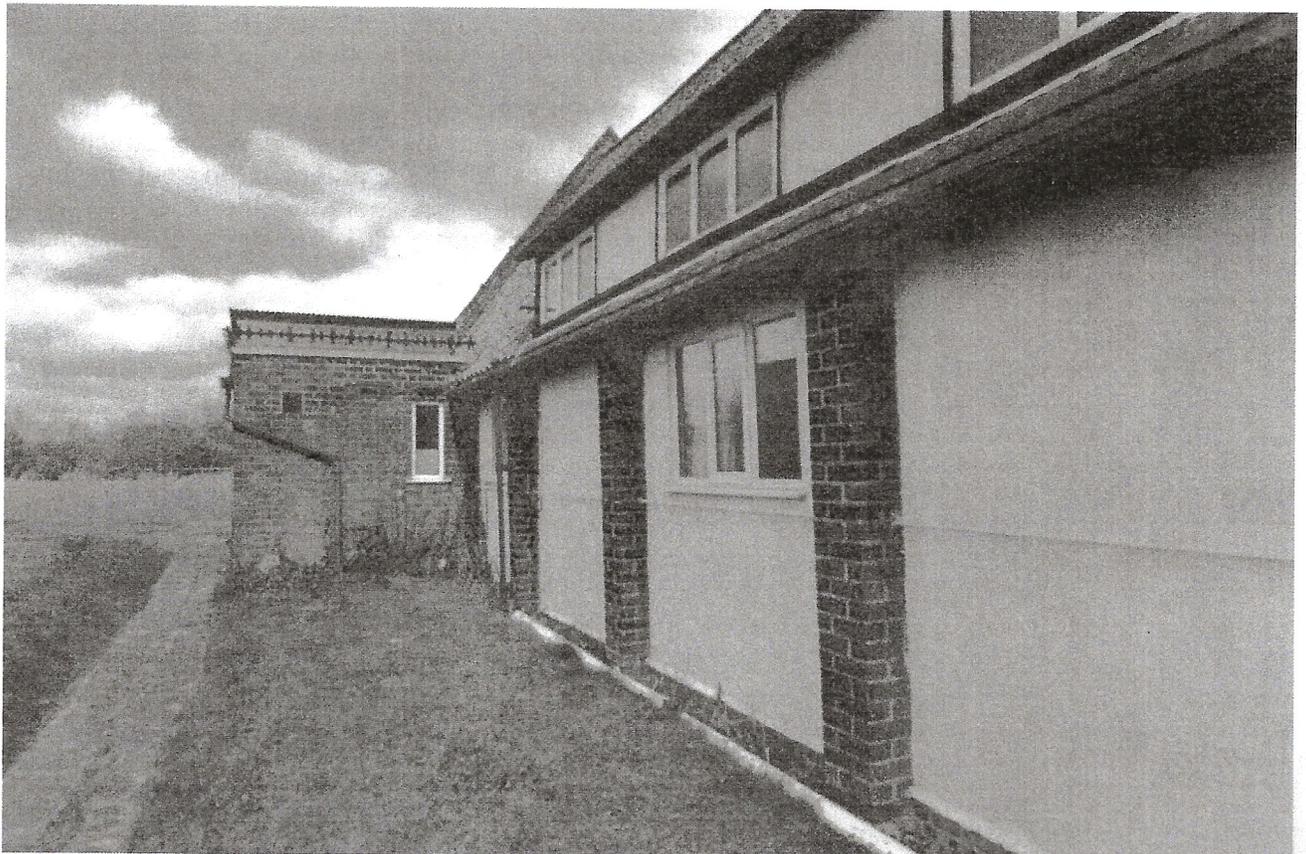
There are obvious signs of structural movement to the building with remedial works having been carried out in the past. Whilst the date of the previous structural works including tie bars and bosses is not known, they do appear to have been in place for some considerable time. Further details of past works should be obtained.

External and internal repointing is evident in several areas, whilst structural cracking of render, mortar joints and brickwork continue to be clearly evident.

Unless the building is to be completely rebuilt, it would seem appropriate to maintain the hall as best as possible until such time as a decision can be taken regards a replacement building. Given the presence of tie bars and cracking, it would be uneconomic to consider improving the foundations or walls alone, and as the roof will need replacement and strengthening, a replacement building in the medium term would seem appropriate.

Such cracking damage should be repointed, in the meanwhile, although further cracking is likely to occur given the other evidence of structural movement to the building. The deformation of the gable wall is undeniable and at the time of inspection, we were able to measure a deflection of between 30-40mm in various parts of the upper section of this brickwork. It would however be appropriate for further longer term monitoring to determine whether such deformation is recent or whether it has been present for some considerable time. Such monitoring is recommended in order to give greater certainty to the timescales for any repair or renewal of the structure. A single inspection is merely a snap shot in time and a meaningful assessment should ideally be made over many months by an appropriately qualified Building Surveyor or Chartered Structural Engineer.

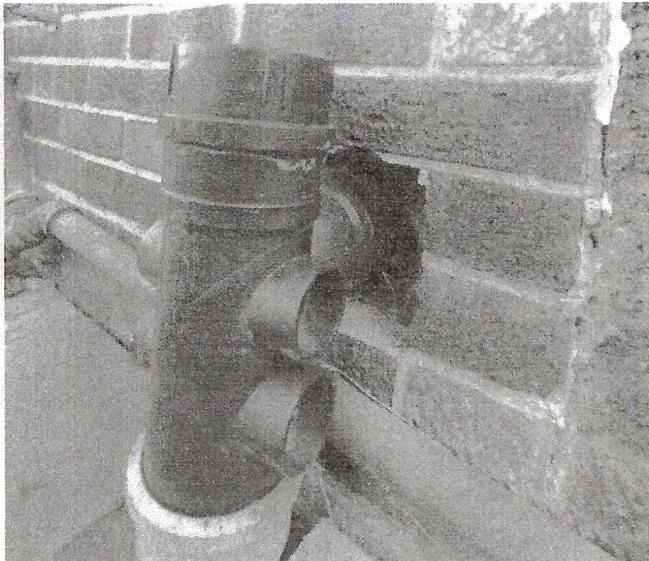
Some service openings such as around the soil and vent pipe to the left hand rear addition flank wall and where pipework has become detached or damaged in a number of places, are likely to contribute to the general deterioration of the structure and repairs should be urgently carried out. Such openings may also allow ingress of vermin.

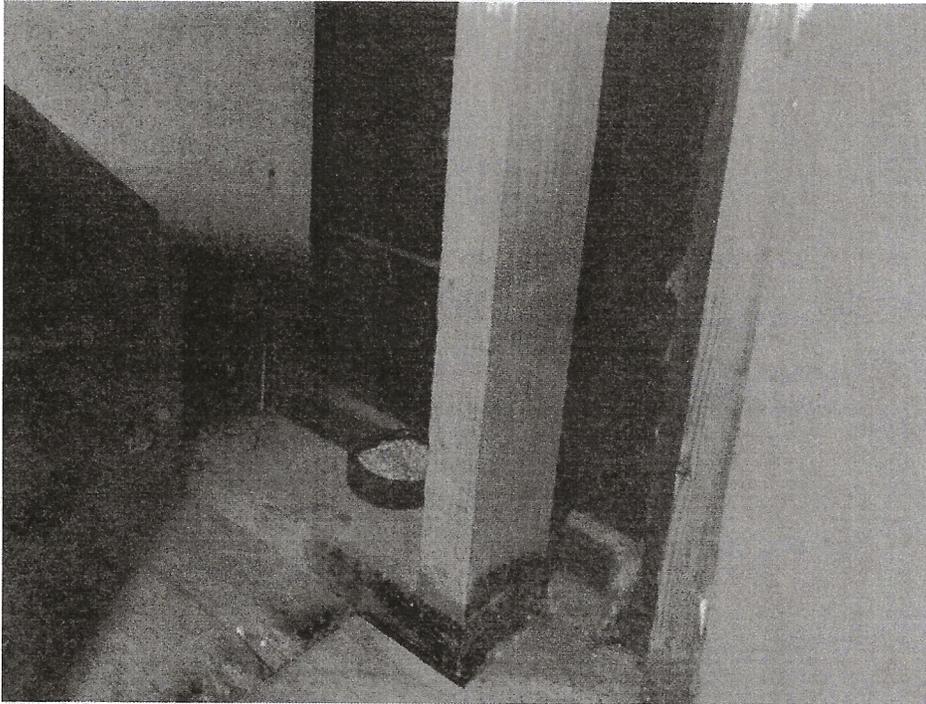
Vermin poison was noted in a tray beneath the stage, indicating there may have been past evidence of such incursions. A specialist pest control expert may be required to effect complete eradication, but ensuring that the exterior is weather and vermin proof will be a pre-requisite.

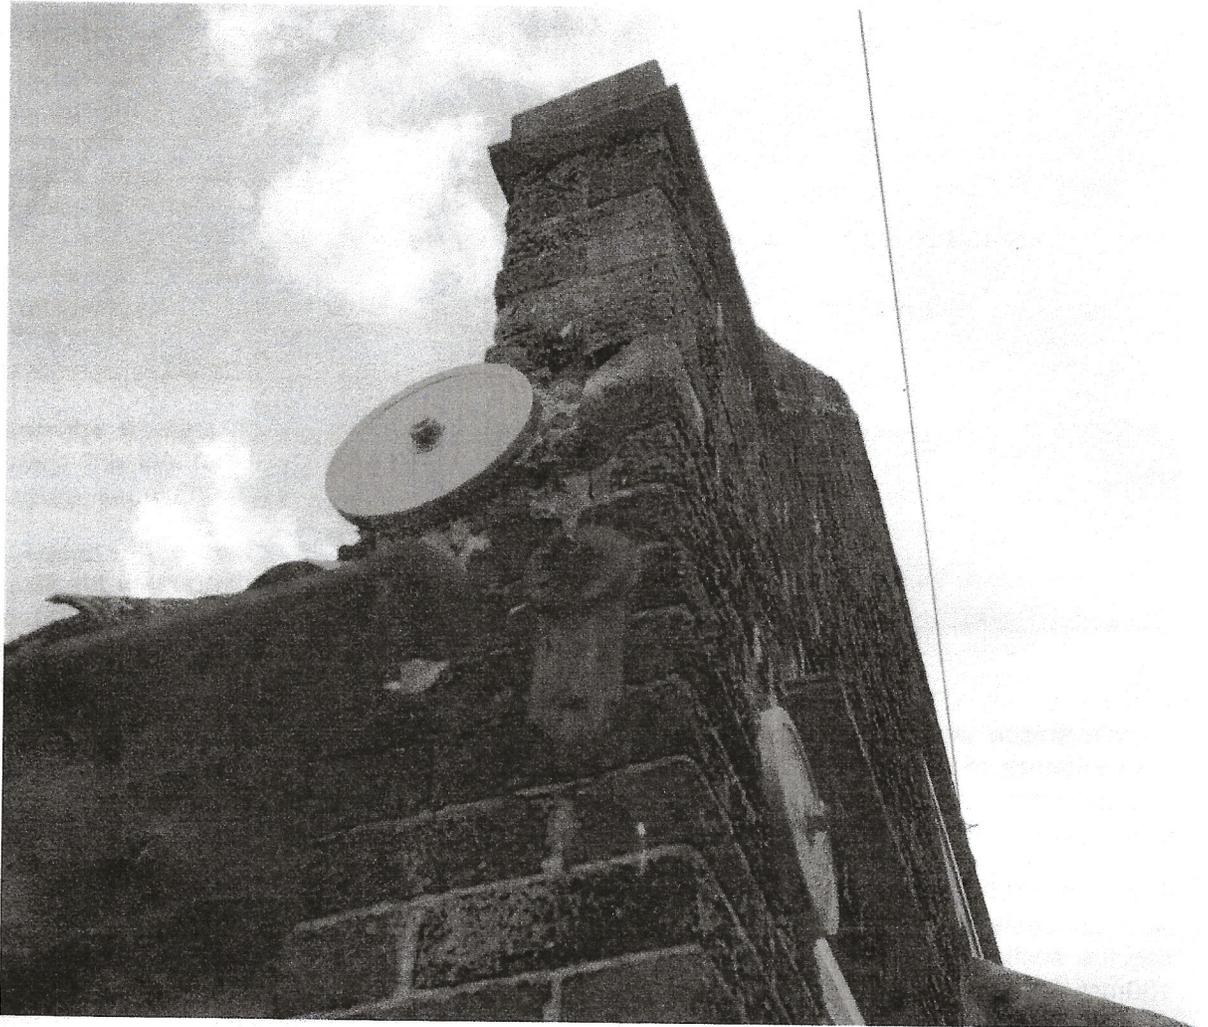
There are a number of parapet walls to the building and these are on the whole, in a very poor condition. Some mortar has eroded completely with bricks likely to be loose and requiring urgent re-securing to prevent injury to anyone passing below.

A secondary defect highlighted by this is that the open jointed brickwork is allowing moisture penetration and damage to the areas beneath. In turn this increase the deterioration to the structure and it is strongly recommended that these areas are addressed immediately and a quotation for repairs should be obtained. Again contractors should be warned of the proximity of suspected asbestos materials and the risks of damaging these areas. Dampness may have allowed rot to occur to adjoining timberwork and the need for associated remedial works cannot be ruled out.

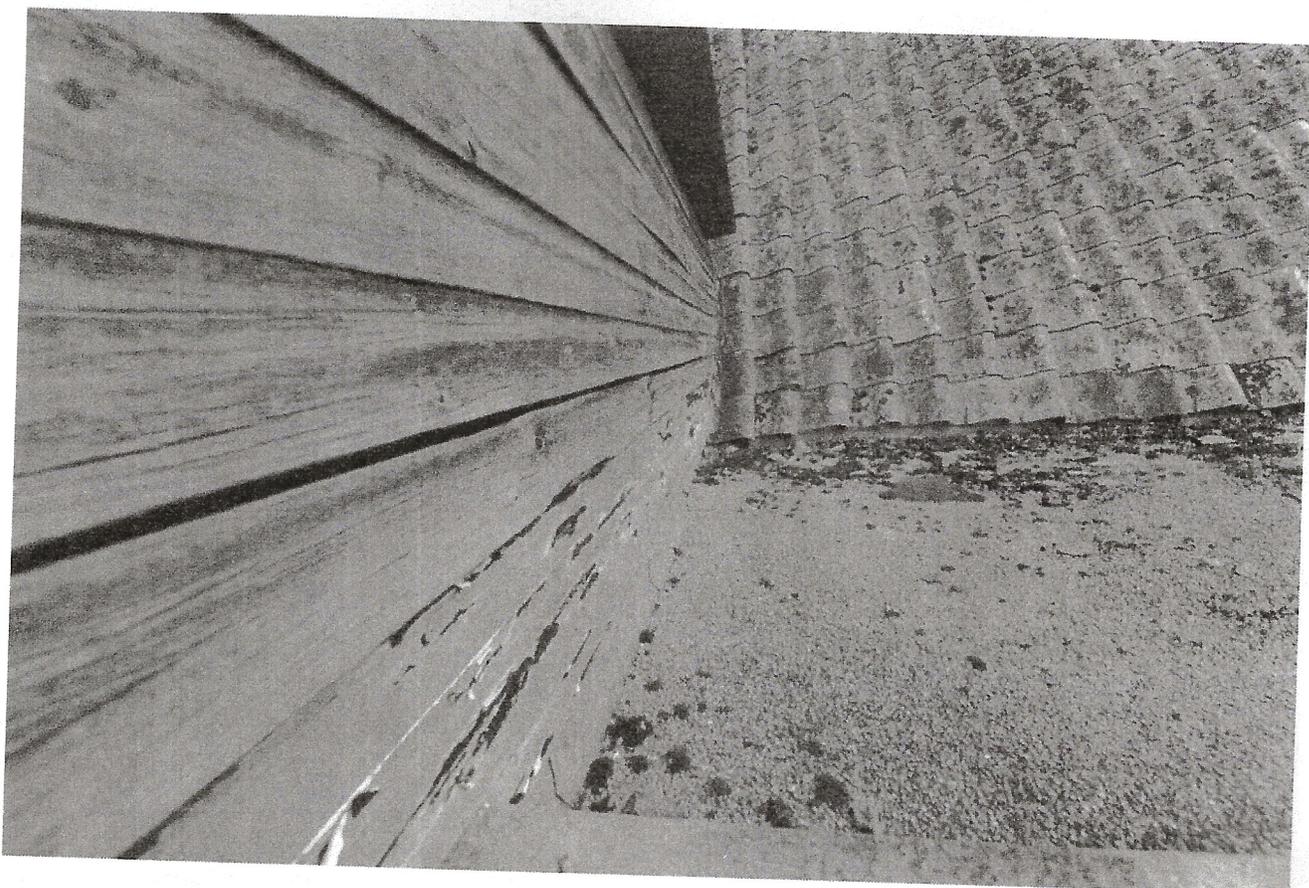
The timber clad vertical wall to the left hand side of the rear addition that faces the road, is in a poor condition. These timbers should be examined and properly prepared / repaired before redecoration. This is also a task that if not carried out in the near future, much more expensive repairs are likely to be required to adjacent elements, especially if damp penetration affects adjacent elements

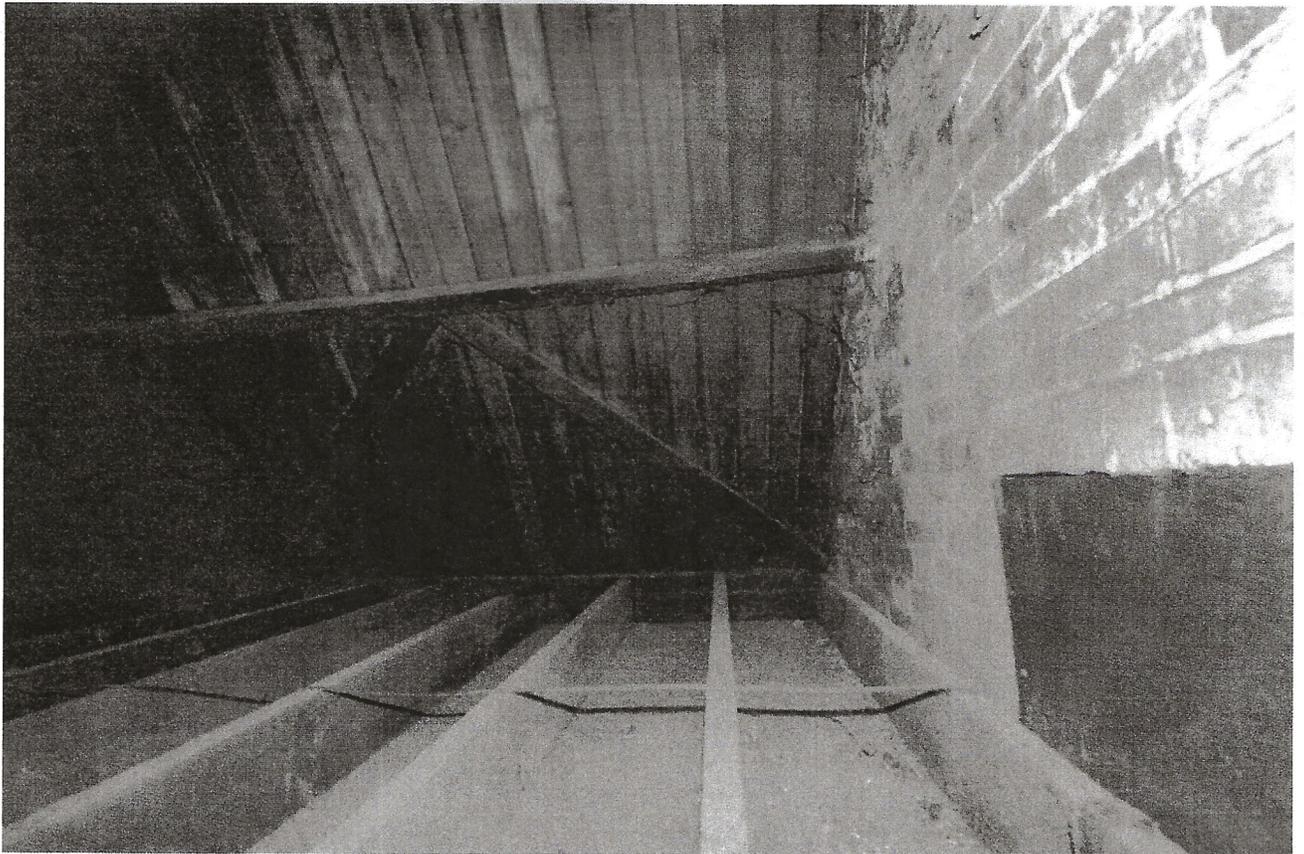
The roof itself is underdrawn with close-boarded timber through which some tile fixing nails were noted to protrude. As the roof slopes are under boarded, battens and tile fixings are hidden from view. Such boarding is a traditional means of secondary defence against driving rain or snow, now superseded by underlay.

The bracing to the roof is of a non-conventional lightweight design and whilst it has presumably been in place since original construction, the structural movement issues are not assisted by such lightweight designs and may well be placing some pressure on the external walls. Ideally additional restraint should be provided, although the cost effectiveness of this at this stage in the buildings life is questionable.

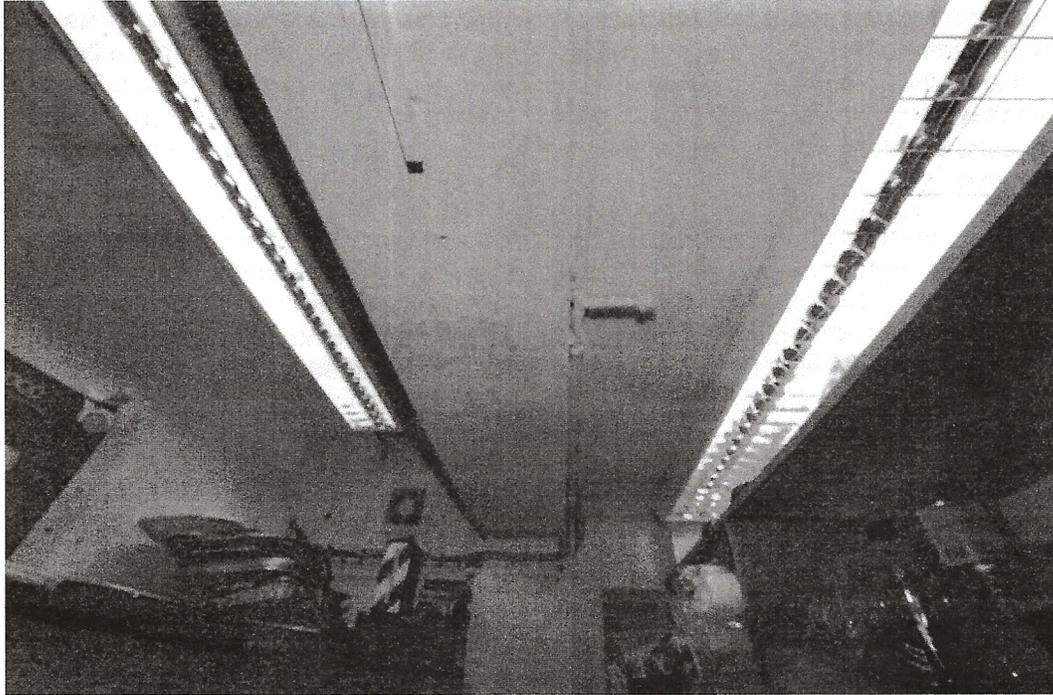
Cracking was evident to some areas, which is likely to reflect upon the general movement and thermal changes to the building. Cracking evident to the beam located in the store room, should be monitored although where adjacent structures have deflected, then such associated cracking is not unexpected. Minor repair should be carried out when next decorated, although care should be taken to ensure the areas contain no asbestos components.

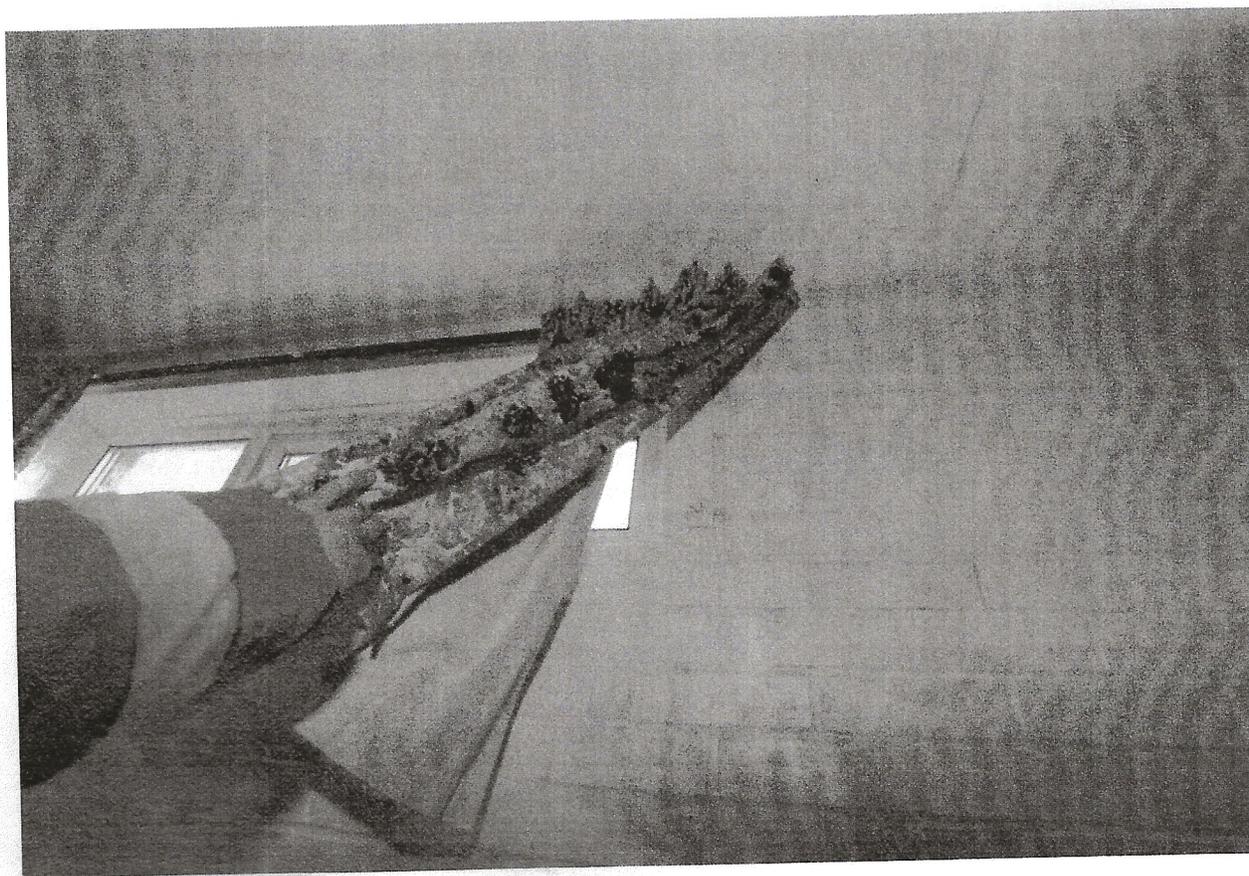
Evidence of black mould from excess condensation was noted, for instance, but not necessarily restricted to the Gents W.C. walls.

The control of condensation involves maintaining surface temperatures above the dew point (the humidity related temperature at which water vapour turns into moisture) and the provision of adequate thermal insulation and proper ventilation. The extent of condensation in a dwelling will depend not only upon its orientation and construction, but also on variable factors such as weather conditions, lifestyle and how the property is heated and ventilated. Unchecked condensation can cause potentially toxic mould, which is harmful to health. This often begins as black spot mould which invariably signifies a condensation issue as opposed to rising or penetrating damp. The control of condensation can often be significantly improved by installing extractor ventilators in bathroom, kitchen and utility areas with ducts arranged to disperse any moisture-laden air to the exterior. This will help remove water vapour at source. The extractors should be operated, preferably automatically, whenever such rooms are in use and ideally set with a suitable over-run facility.

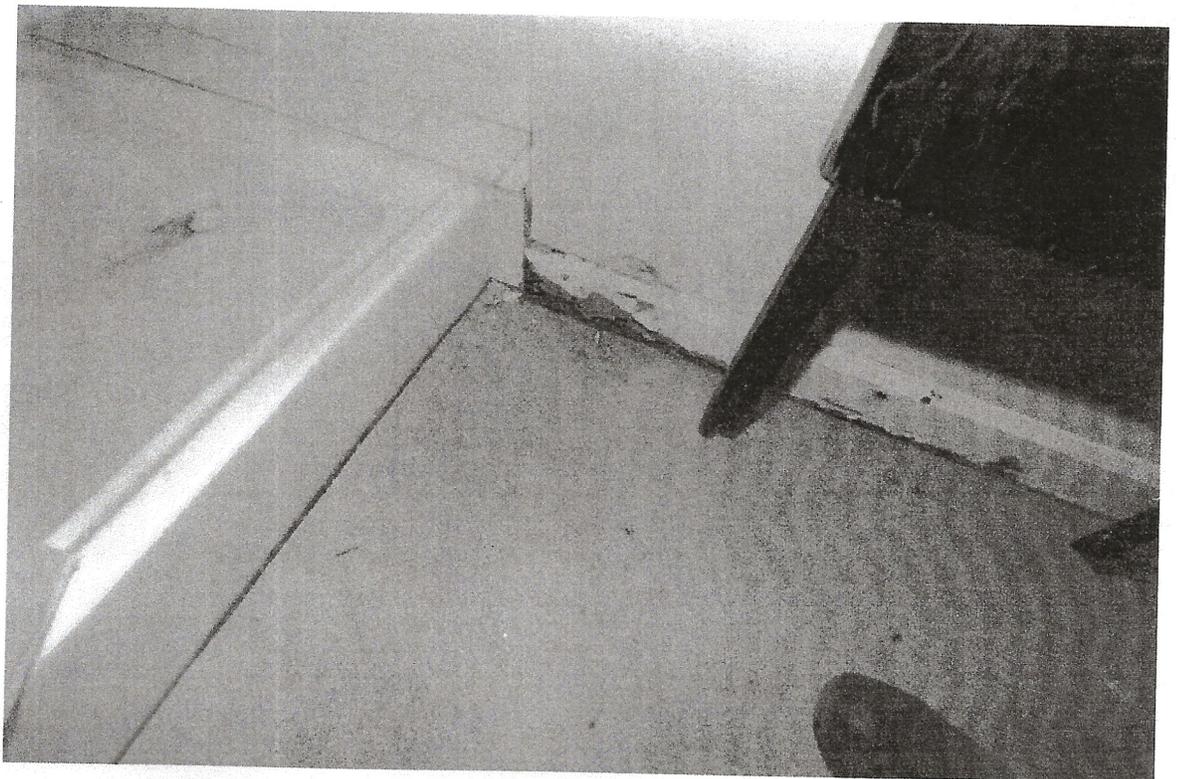
Some leakage was apparent to the left hand side shower room and damage has occurred to adjacent timbers which will require further investigation (see preceding comments).
