**Cropwell Bishop Memorial Hall**

**Building Survey**

**A Detailed Property Inspection Report**

Inspecting Surveyor: Ian Prince, MRICS MBEng

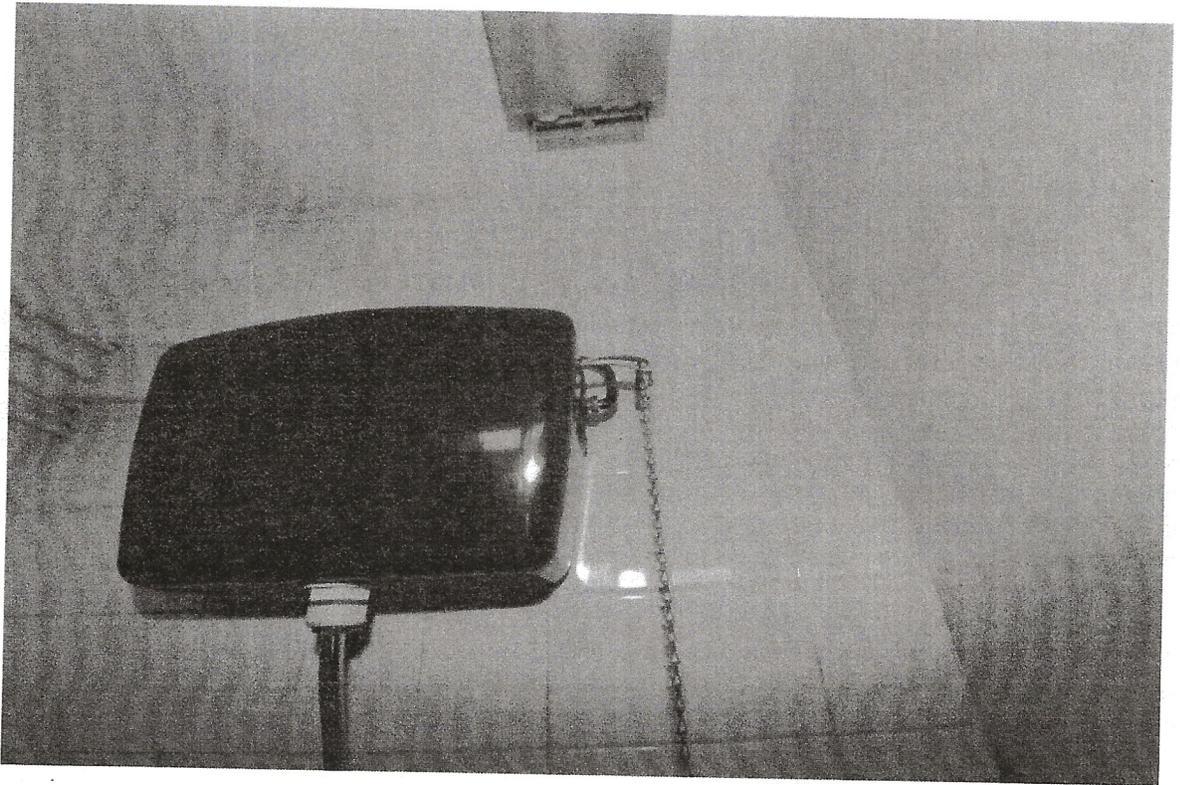
### **Sanitary Fittings**

The fittings are a mix of dated and more modern styles, which are serviceable although subject to normal wear and tear. They have not been inspected in detail.

Some sanitary fittings may incorporate asbestos fibres and specialist advice should be obtained prior to any work being carried out to such items. In particular seats, covers and cisterns in some cases may have an asbestos content, but only laboratory analysis can confirm.

Flexible sealants must be maintained at the junction between some sanitary appliances (particularly around the showers) and surrounding wall/ledge surfaces to minimise the risk of water penetrating to areas beneath. The seals should be regularly checked as occasional renewal will be required.
